MINING TYRE SOLUTIONS

Technical Report

DIFFUSION TYRE EXPLOSION

WOOD LEFT IN TYRE

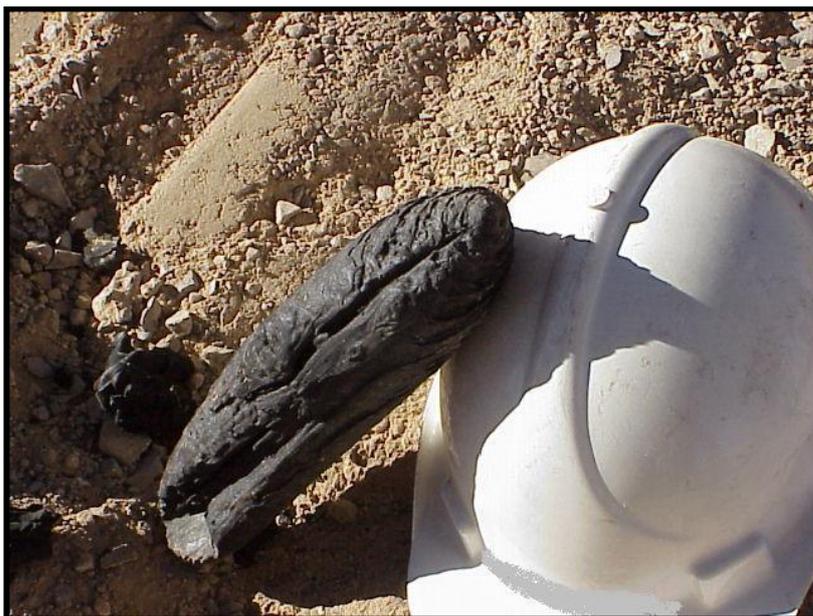
There were two pieces of wood found inside the tyre¹. Each was approximately 7cm – 8cm in diameter. One was approximately 29cm long and the other approximately 56cm long. The total surface of each piece of wood was carbonised (refer Figure 1).

Figure 1 – One of two pieces of charred wood found in the tyre

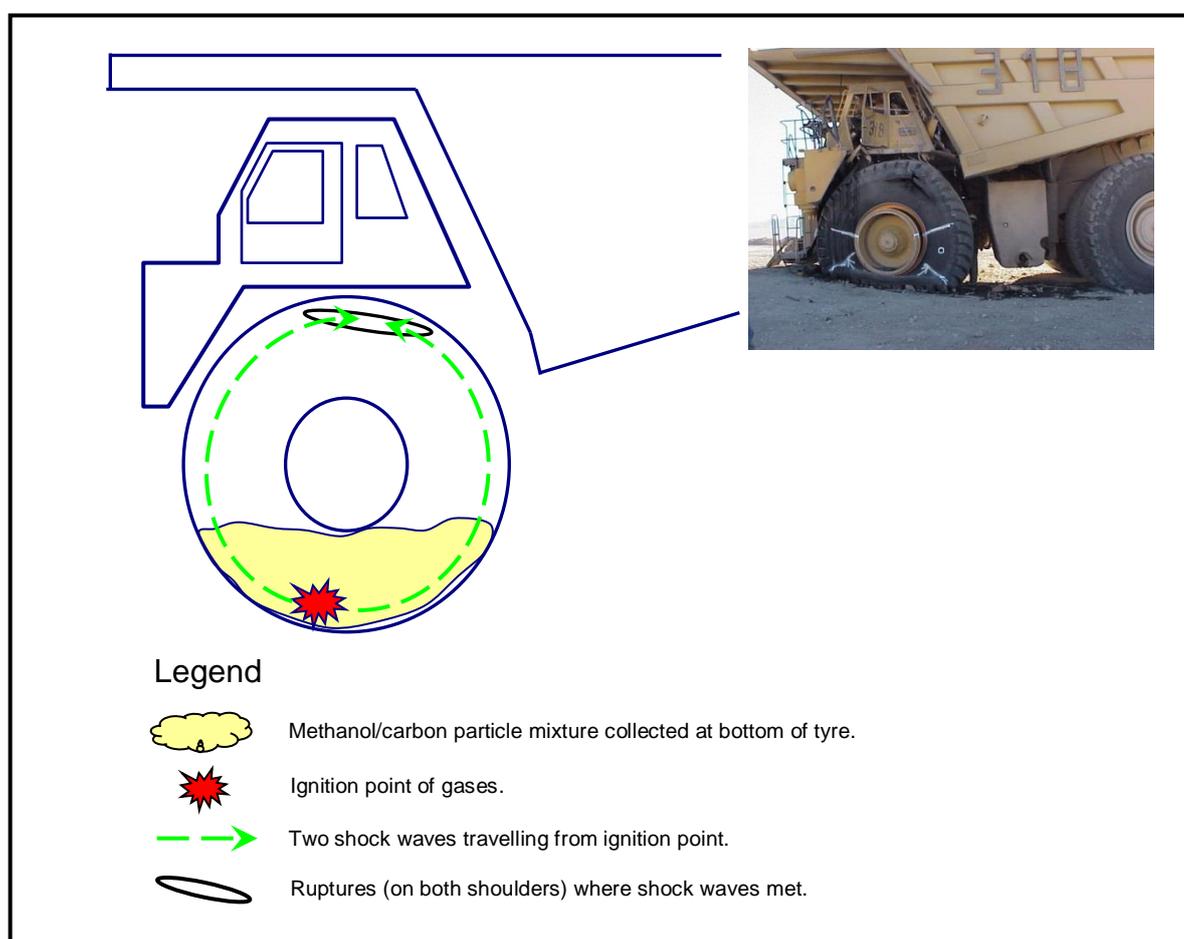
Diagram 1 – Schematic of the exploded tyre on the haul truck showing the collection of gases at the bottom of the tyre, the ignition point of the explosion (slightly forward of the very bottom of the tyre), the two shock waves moving away from the ignition point – meeting 180° away and rupturing the outer and inner shoulders (slightly behind the very top of the tyre) under the driver's cabin of the truck.

The fact that the tyre exploded just as the truck braked to a stop while in a right hand turn indicates that the sudden load transfer to the left front tyre (through a combination of braking and turning) may have produced a zone of local compression (with an associated increase in energy) in the methanol vapour mix creating the thermodynamic conditions for auto-ignition.

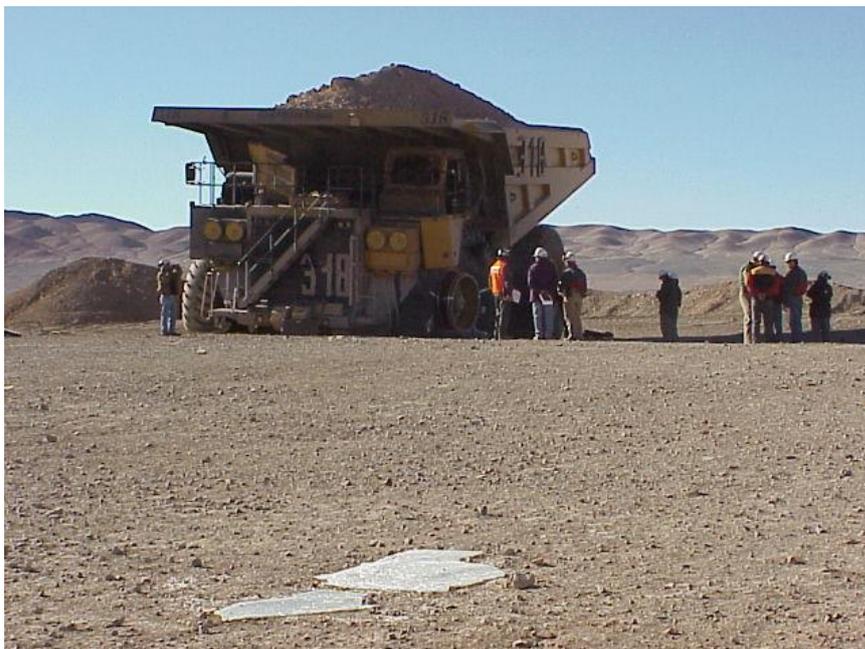
Photograph 1 – Haul truck at the dump after the explosion of the left front tyre, the tyre directly below the operator's cabin. The right front tyre was deflated for safety reasons after the explosion. The broken windscreen from the truck is in the foreground.

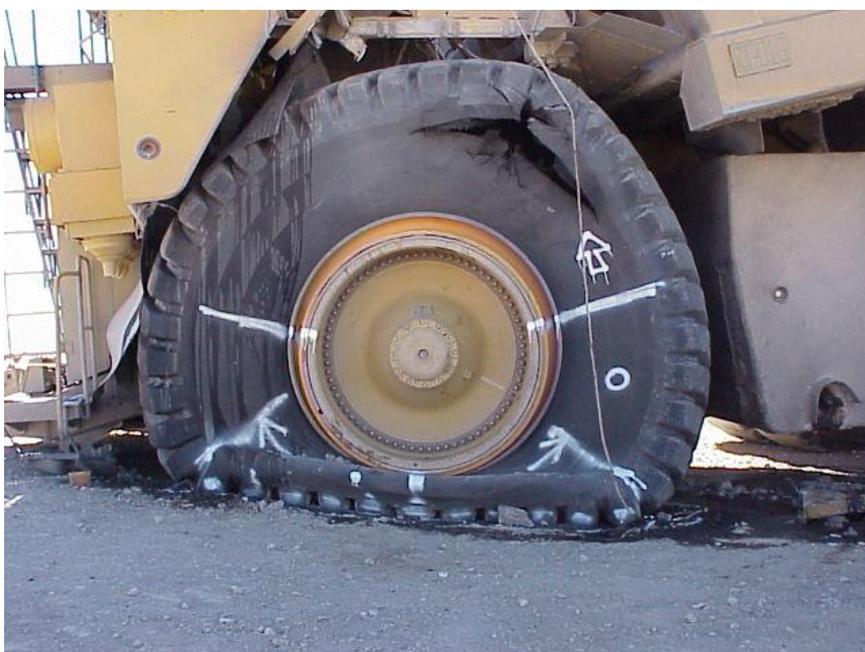
Photograph 2 – The orientation of the exploded tyre (the truck had momentarily stopped immediately prior to the explosion). The explosion initiation zone is at the bottom of the tyre, and the two rupture zones (one on each shoulder) are near the top of the tyre.

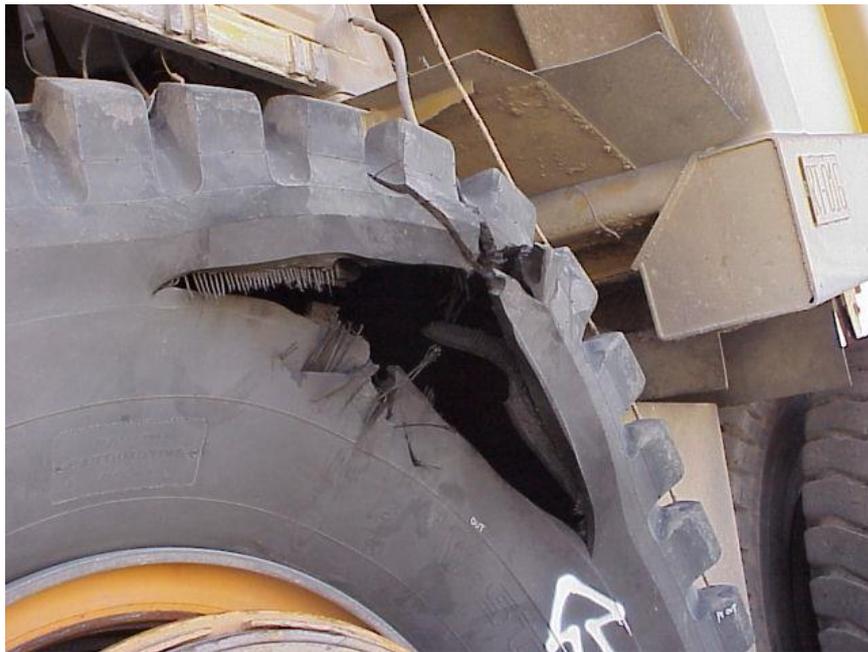
Photograph 3 – Rupture, near the top of the tyre and on the outer shoulder, caused by the explosion.

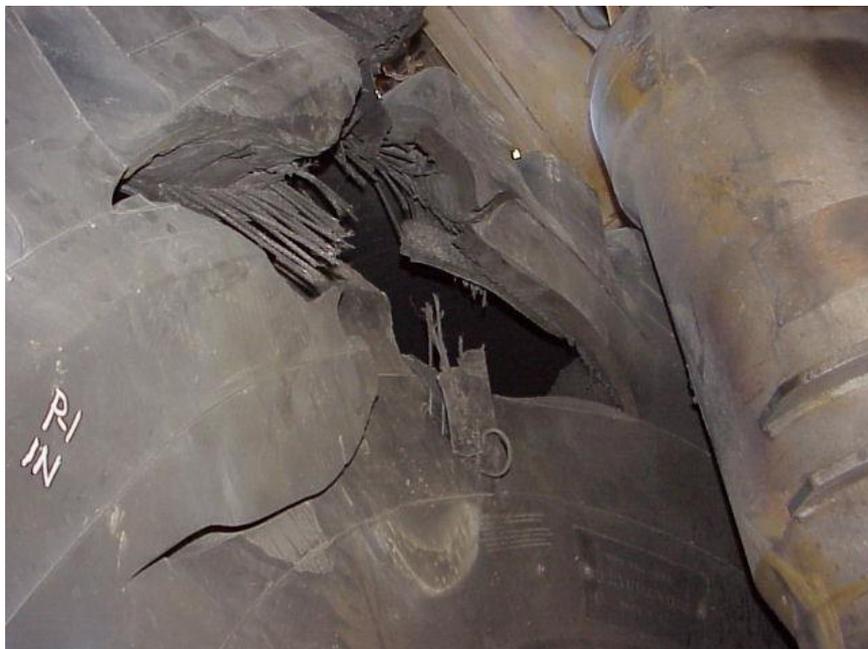
Photograph 4 – Rupture, near the top of the tyre and on the inner shoulder, caused by the explosion.

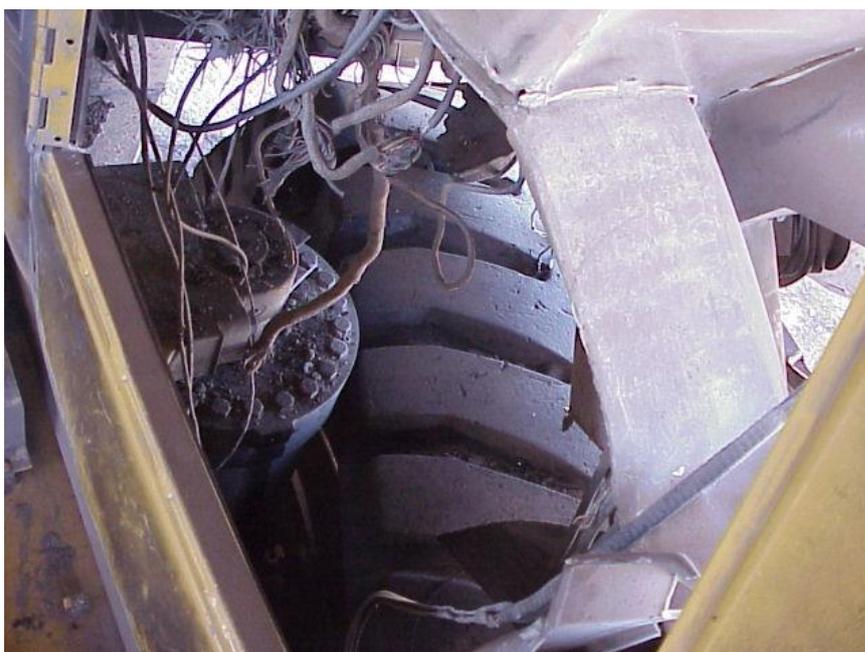
Photograph 5 – Looking down at the exploded tyre from the driver's cabin.

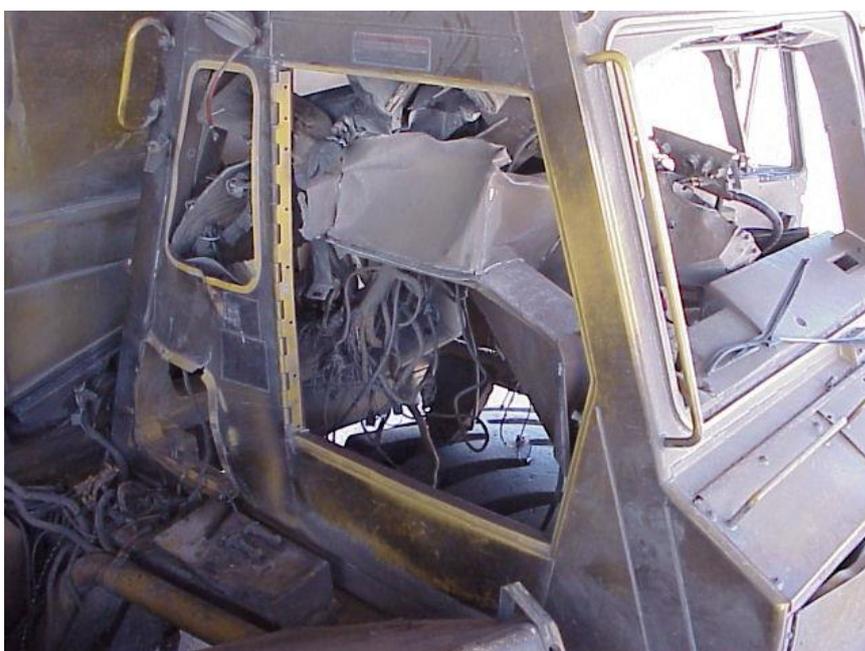
The truck was extensively damaged directly around the exploded tyre. The floor of the driver's cabin had been pushed upwards causing major damage to the whole cabin. Sections of the walk platform around the driver's cabin were blown out of place and the left front suspension cylinder had collapsed through the loss of oil/gas due to damage to hoses and piping.

Photograph 6 – Damage to the driver's cabin caused by the explosion air blast (there was very little debris expelled from the exploded tyre, and the tyre itself did not contact the cabin).

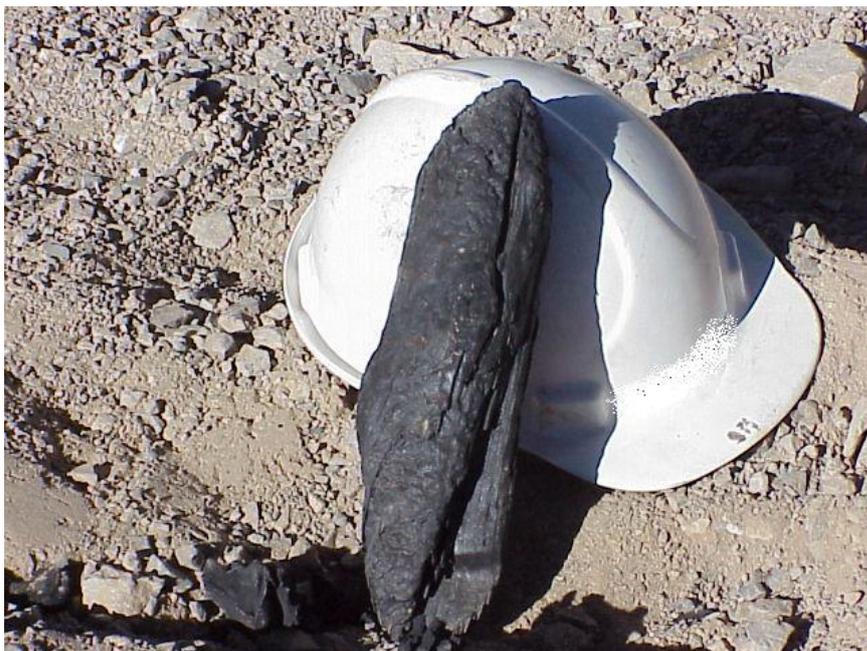
Photograph 7 – The first piece of charred wood found when the exploded tyre was removed from its wheel rim.

1. Properly inspect the inside of a tyre before mounting it onto a rim to ensure that the tyre contains no foreign objects. If it contains foreign objects, remove them.

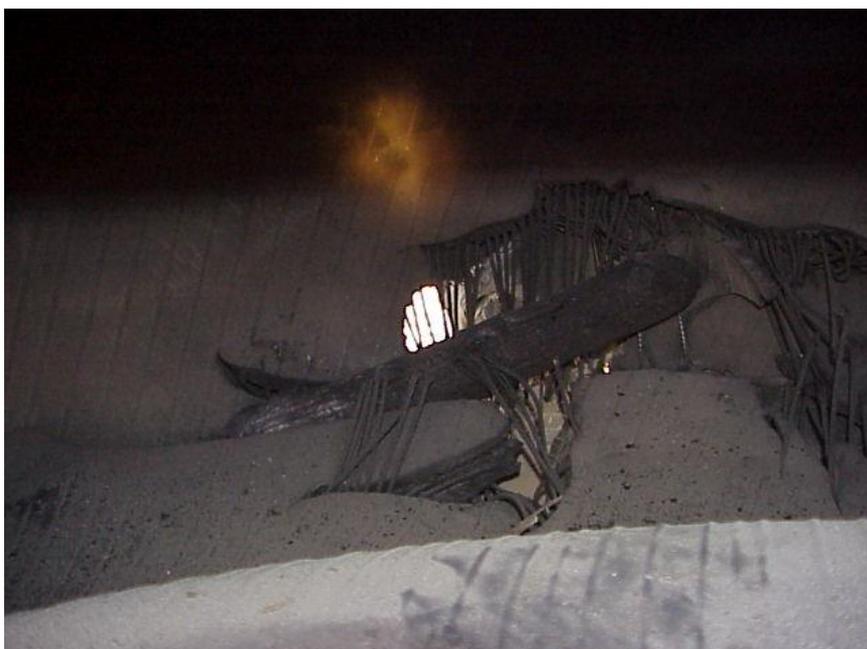
Photograph 8 –The second piece of charred wood found when the exploded tyre was removed from its wheel rim.

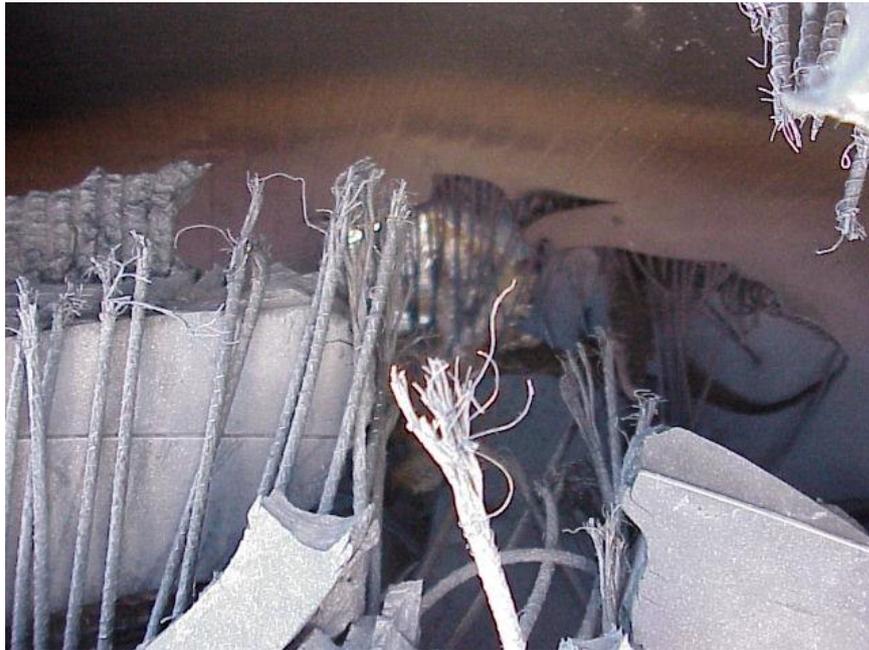
Photograph 9 – Burst steel carcass cords at the rupture zone on the outer shoulder of the exploded tyre. These cords showed no indication of fatigue failure, only tension failure.

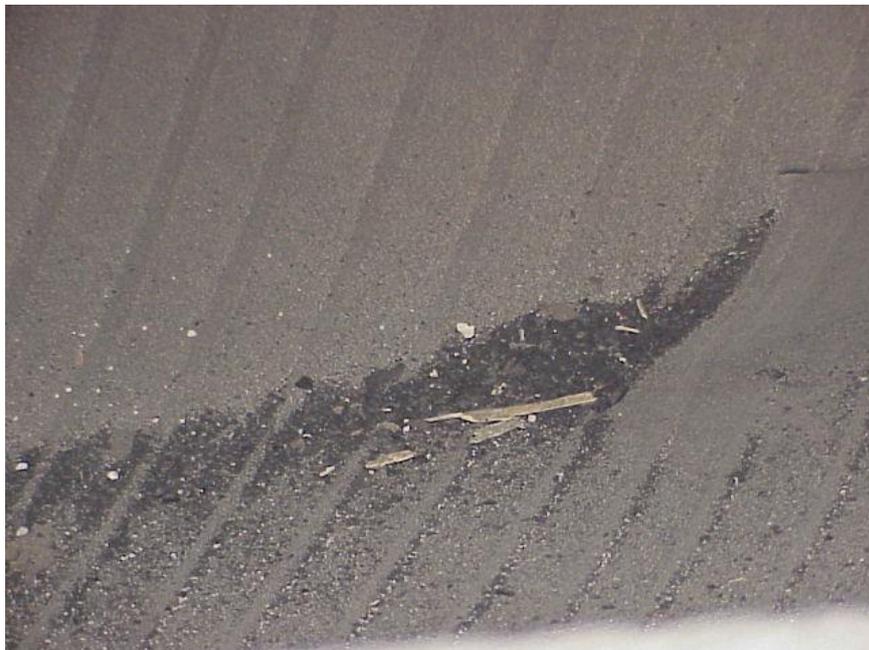
Photograph 10 – Residual material found inside the exploded tyre, including uncharred pieces of wood.

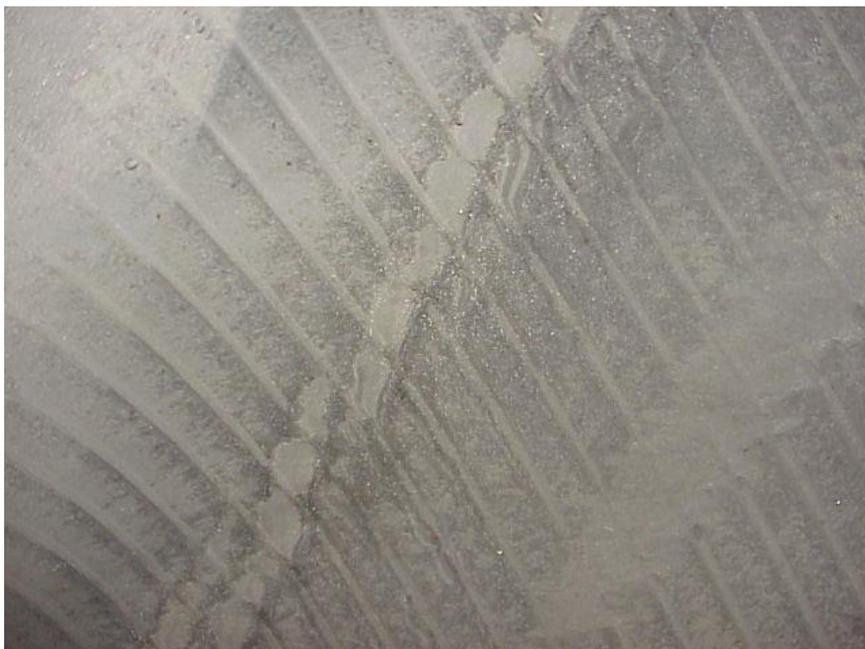
Photograph 11 – Circumferential crease marks observed in the shoulders of the exploded tyre near the explosion initiation zone.

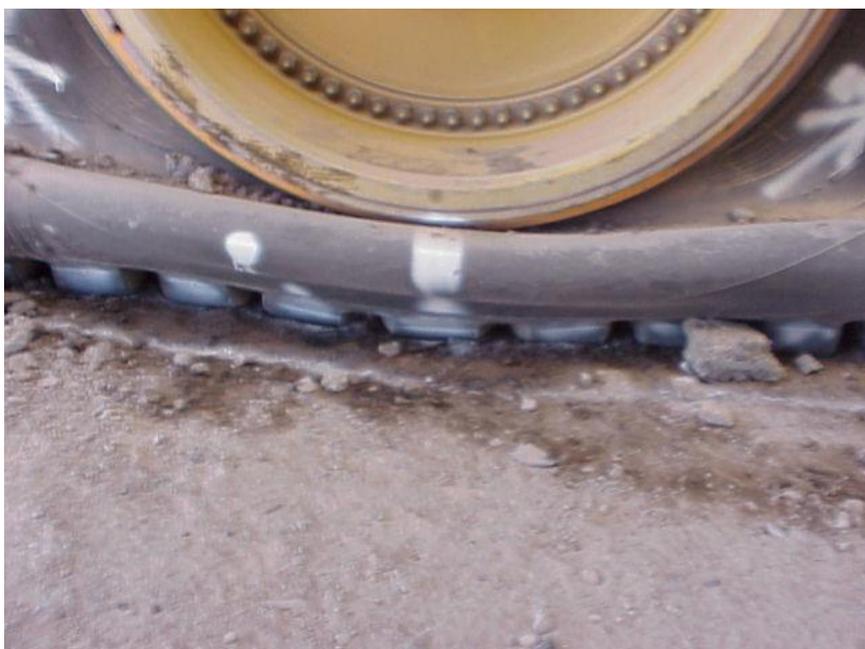
Photograph 12 – The crease marks shown in Photograph 11 were caused by the tyre folding onto itself after it had exploded.

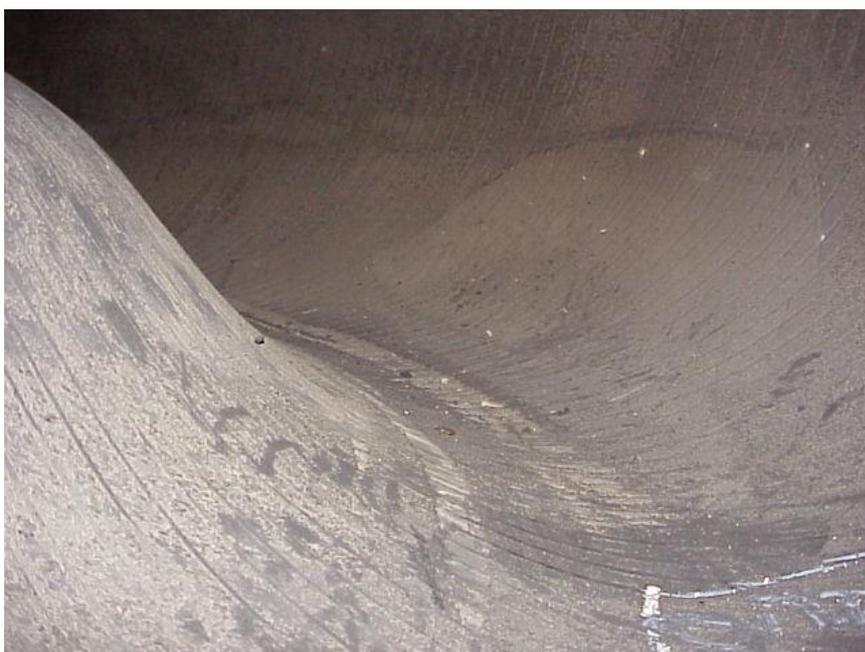
Photograph 13 – Inner liner of the tyre around the explosion initiation zone. The white chalk marks border the area from which scrapings of inner liner material were taken for laboratory analysis.

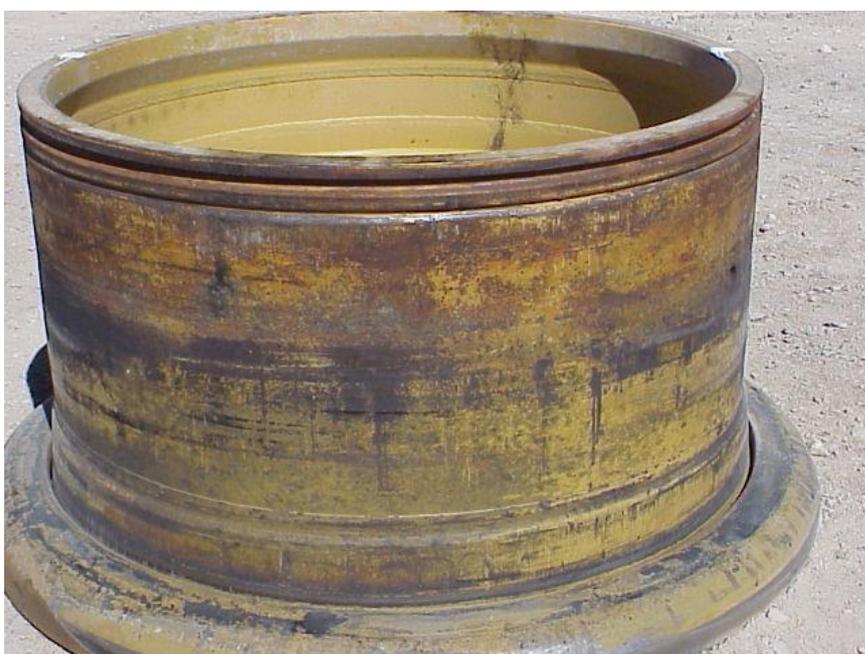
There was no visible damage to the rim of the exploded tyre.

Photograph 14 – The rim components showed no visible evidence of damage or of the explosion.

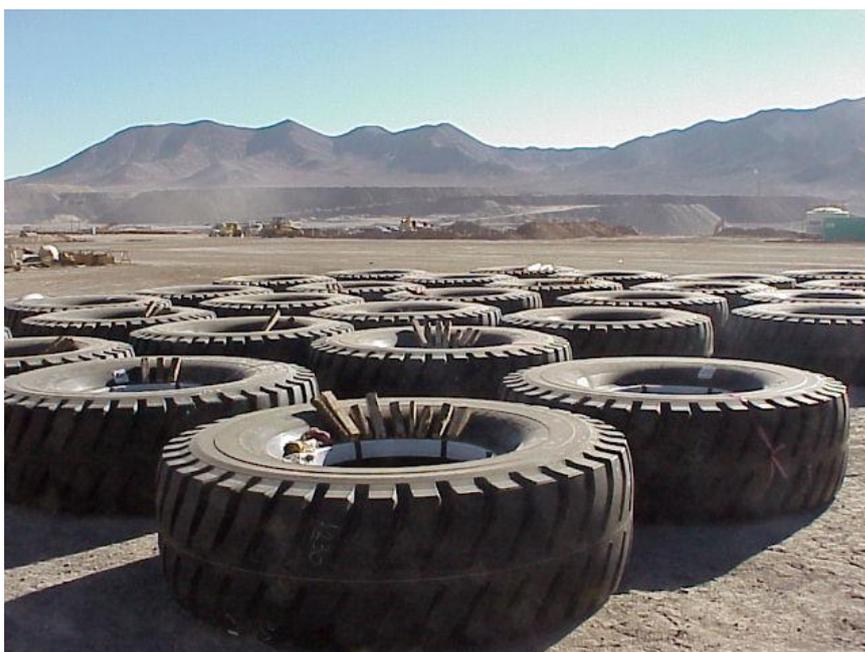
¹ The wood had been used as packing during sea-freight of the tyres from their country of manufacture. During unloading of the tyres, the wood had been placed inside the tyre. This wood had not been removed from the tyre when the tyre was mounted onto the rim.

Photograph 15 – Pieces of wood removed from a batch of new tyres that had been delivered to the mine site. The wood is used as a packing material during the sea-freight, and appears to have been placed in the tyres when the tyres are unloaded at the port.

2. Recommend to all tyre companies that wood spacers not be used in their tyres (even though a wood spacer had not been used in this case).
3. Recommend to the appropriate shippers and port authorities that wood, or other objects, not be placed inside tyres.

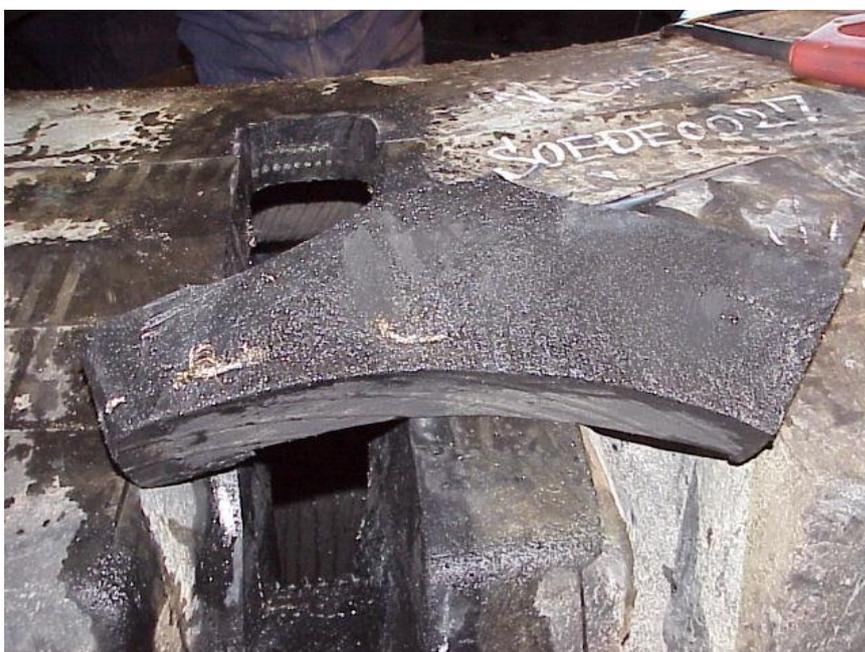
Photograph 16 – A section of the tyre's shoulder was cut out at the explosion initiation zone to determine if there was any failure or separation in the internal structure of the tyre that may have contributed to the explosion. There was no evidence of any damage to the tyre's internal structure.

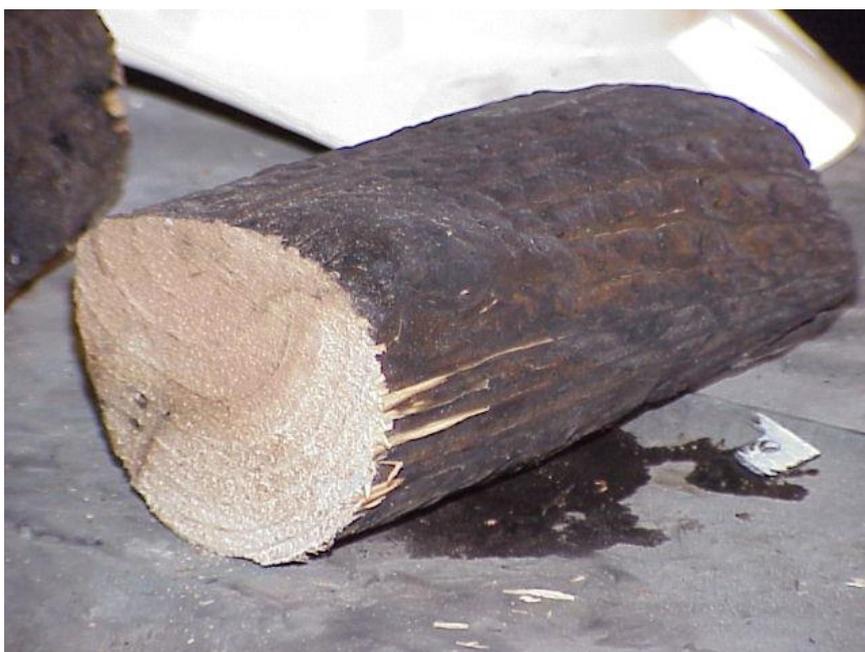
Photograph 17 – Cut section of one of the two pieces of wood found in the exploded tyre. Along the length of the wood the depth of carbonisation was very shallow (it was a little deeper at the ends).
